# Manhole Inspection Summary

Manhole # S43G\_\_045MH

**Inspection** ☐ Is Incomplete Rating: **3) Fair**

**Location** Address: **rear 201 mason ct**

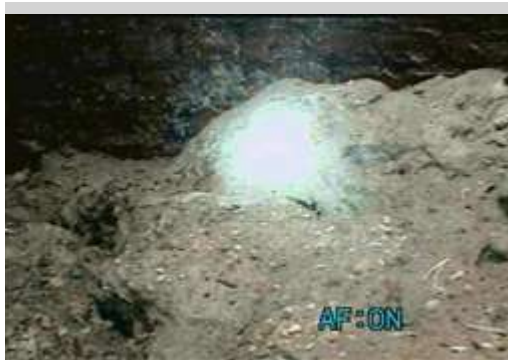
Defect 3

Condition: ☐ Sound ☐ Cracked ☐ Root Intrusion ☐ Deteriorated ☐ Leaks ☒ **Debris**

debris chan

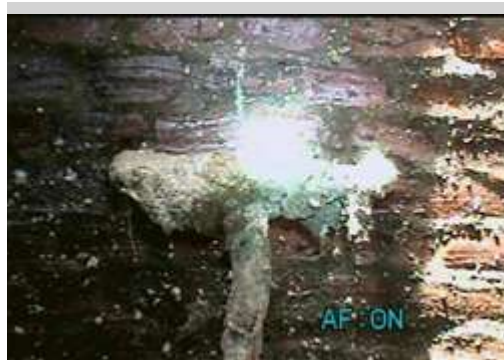
Defect 2

Infiltration: ☐ None ☐ Joint ☐ Cracks ☐ Mortar ☐ Roots ☒ **Wall**

☒ **Evidence Of Surcharge** Depth: **4.** (ft.) ☐ Active Surcharge Present

infiltration and surcharge

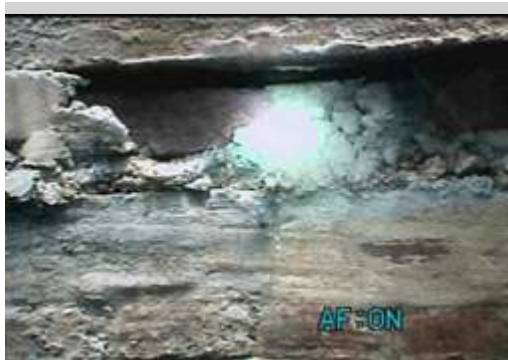
Defect 1

Condition: ☐ Sound ☐ Cracked ☐ Root Intrusion ☐ Loose Brick ☒ **Deteriorated**

adj

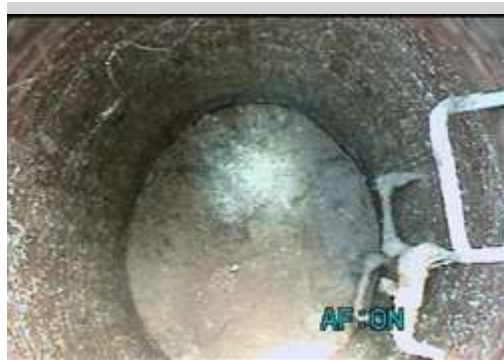
Defect 4

Condition: ☐ Sound ☐ Cracked ☐ Root Intrusion ☐ Deteriorated ☐ Leaks ☒ **Debris**

Count: **4** Missing: **0** ☒ **Corroded**

bench debris & corroded steps

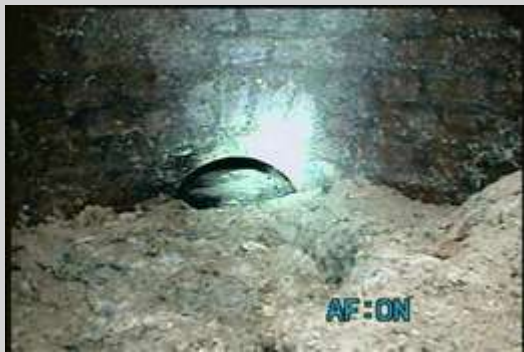
12 O'Clock Outflow

Deposits: ☐ None ☐ Mud ☐ Sludge ☒ **Debris** ☐ Grease

Silt Depth: **6** (in.) Deposits Extent: **Heavy**
